# Food Ingredient Manufacturer Cuts Tank Cleaning Time by 75% and Offsets Equipment Cost in Less Than a Week

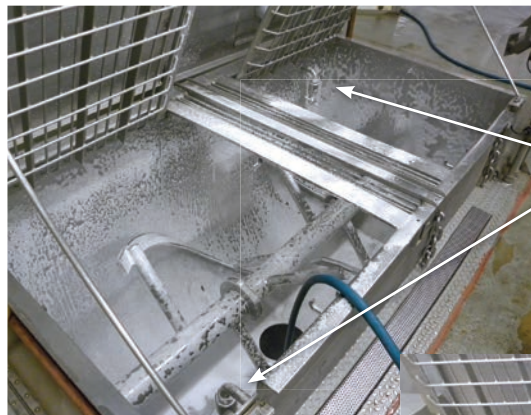
Ribbon blender being cleaned

TankJet 75 tank cleaners are installed in opposite corners of the blender to ensure thorough cleaning of all interior surfaces

Spraying Systems Co.'s TankJet® 75 tank cleaner solved the customer's problem. Two TankJet 75 units, positioned in opposite corners of the blender, provide effective cleaning. Shadowing, caused by the ribbon blade and other internal obstructions, is overcome by the use of two tank cleaners that ensure all surfaces are thoroughly cleaned. Hot water is pumped to the tank cleaners at 50 psi (3.4 bar) with a flow rate of 8 gpm (30 lpm). The powerful impact of the water jets ensures repeatable results with every cleaning cycle.

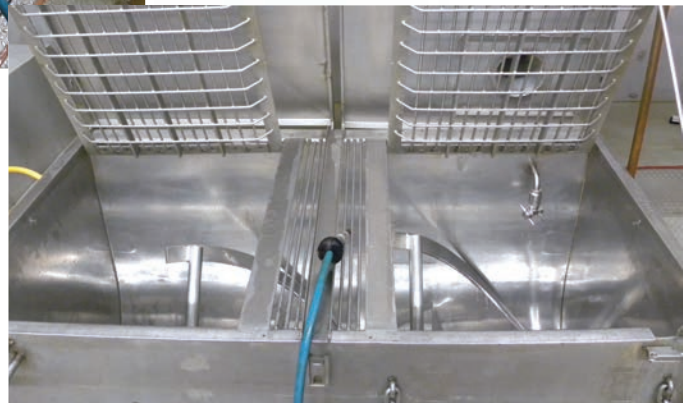
Ribbon blender after cleaning

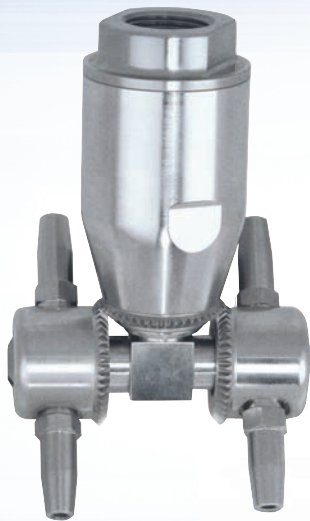
**TankJet 75 tank cleaners** use solid stream nozzles that rotate in multiple axes to provide complete coverage of tank interiors. The 360° indexing pattern is completed every 45 seconds.

The units are available with a two- or four-nozzle hub and can be used with tanks up to 30' (9.1 m) in dia.

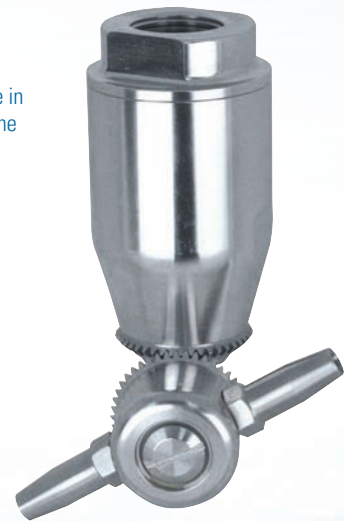
360° Spray
