# Food Ingredient Manufacturer Cuts Tank Cleaning Time by 75% and Offsets Equipment Cost in Less Than a Week

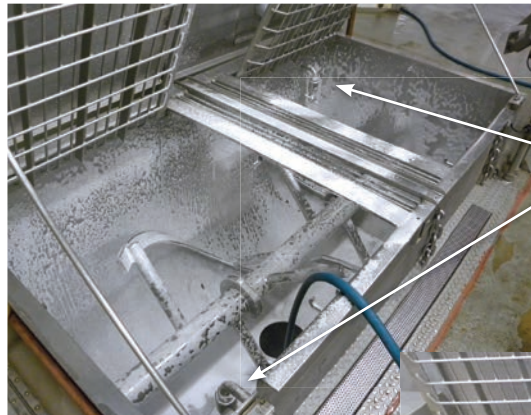
Ribbon blender being cleaned

TankJet 75 tank cleaners are installed in opposite corners of the blender to ensure thorough cleaning of all interior surfaces

Spraying Systems Co.'s TankJet® 75 tank cleaner solved the customer's problem. Two TankJet 75 units, positioned in opposite corners of the blender, provide effective cleaning. Shadowing, caused by the ribbon blade and other internal obstructions, is overcome by the use of two tank cleaners that ensure all surfaces are thoroughly cleaned. Hot water is pumped to the tank cleaners at 50 psi (3.4 bar) with a flow rate of 8 gpm (30 lpm). The powerful impact of the water jets ensures repeatable results with every cleaning cycle.

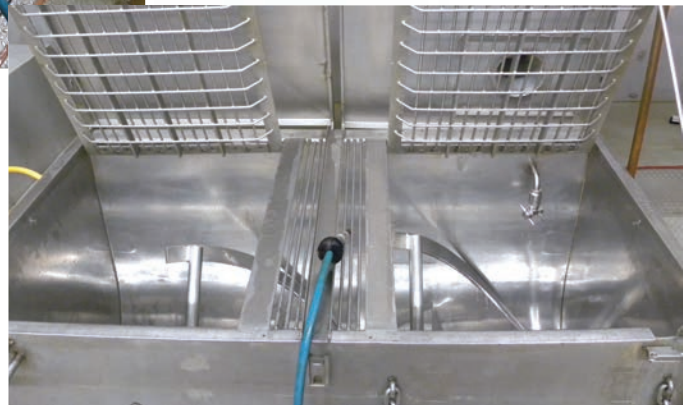
Ribbon blender after cleaning
