COAL-FIRED POWER PLANT REDUCES WATER USE BY 50% AND IMPROVES WORKER SAFETY WITH NEW WASHDOWN NOZZLES

Case Study No. 297 ©Spraying Systems Co. 2022

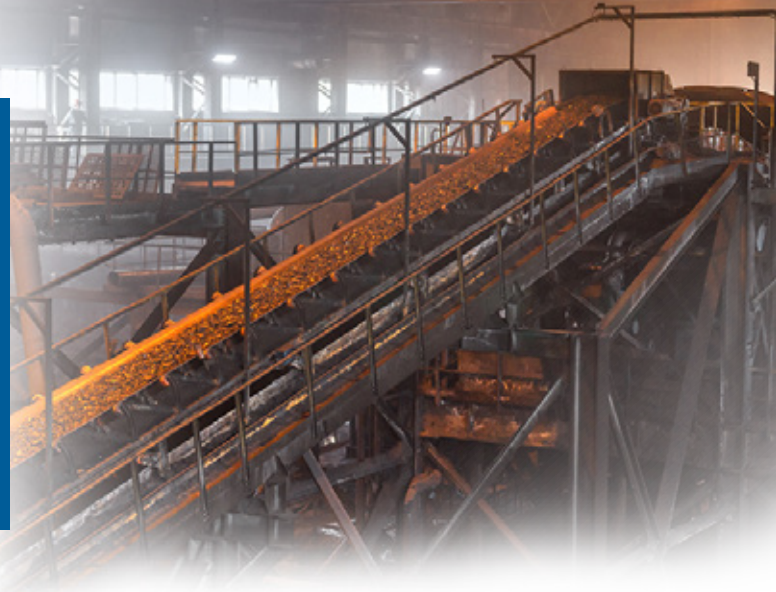
We recommended replacing the existing washdown nozzles with TankJet® nozzles, a combination of fluid-driven rotating nozzles and fixed nozzles. TankJet 6353 and TankJet 80 nozzles were strategically placed to ensure efficient, coverage of conveyors and tunnel walls. Since the installation of the new nozzles, the flooding and worker safety issues have been eliminated and additional manual cleaning is no longer required.

The new approach to washdown has yielded many benefits for the power plant. Water use has been reduced by 50%, a result of replacing flooding nozzles with more efficient nozzles and eliminating additional cleaning by workers using hoses. The estimated savings on labor alone is estimated at US\$150,000 per year. In addition to the labor savings, the plant is benefitting from lower wastewater treatment costs and energy savings from the use of smaller pumps to supply the nozzles. Most importantly, the slip/fall hazard has been eliminated.

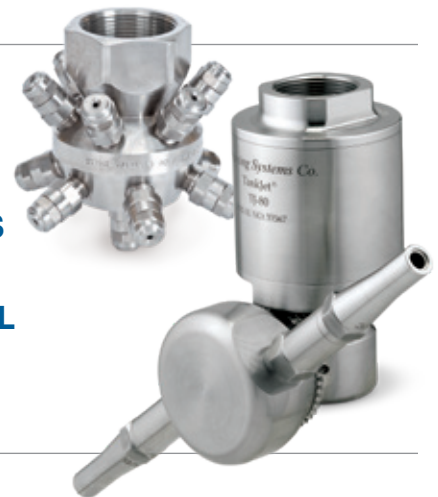
**BETTER
CLEANING
USING LESS
WATER;
NO MANUAL
LABOR**
